Improvements of hygiene in radiology

## First experiences with the new CT Table Cover (Pearl Technology) in clinical practice

Professor Dr. Stephan Zangos, Chief Physician at the Institute for Radiology & Nuclear Medicine, Alb Fils Kliniken Göppingen

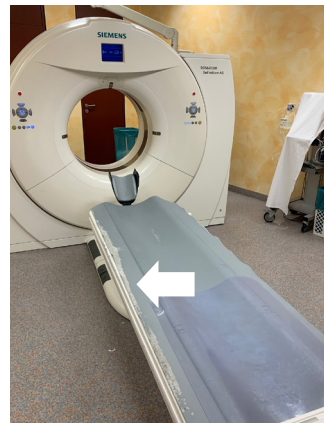
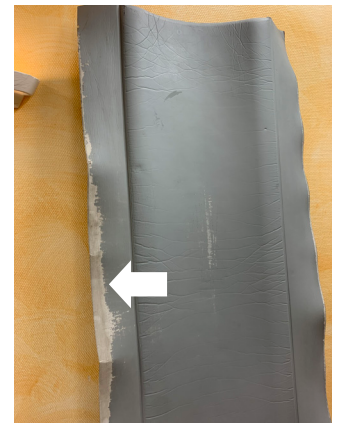
**Figure 1:** Illustration of mechanical damage (arrow) of the patient mattress on the CT with severe wear of the flaps on the right side due to frequent patient transfer.

the foams. We also observed that the wings of the patient mattress on the CT were particularly worn out on the side where patient are transferred onto the table.

To protect the mattress, many clinics use at least a plastic mat in the foot area (Figure 1), but this does not provide complete protection of the mattress. In addition, these plastic mats can cause image artifacts, so that they can only be used in areas which are not relevant for the image.
